INSPECTION REPORT

CLIENT:	K&S Power Tongs	UNIT/RIG:	KS 1102
EQUIPMENT:	Casing Elevator	MAKE/MODEL:	AOT/ 11 3/4" - 90º
RATING:	65 Ton	SERIAL NUMBER:	119104

CERTIFICATE OF COMPLIANCE

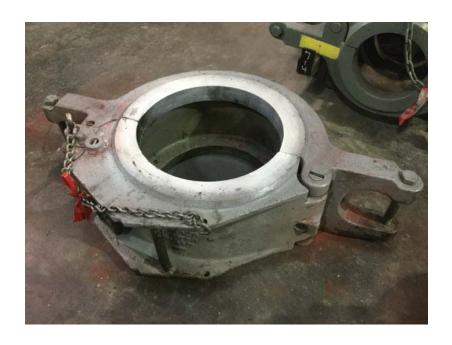
EQUIPMENT PHOTOS

ACCEPTABLE:	X REJECTED:	DATE OF INSPECTION:	April 11, 2019
TECHNICIAN:		COMMENTS: NA	
LEVEL II OR SO CONTINUE TO SO CONTIN	cn=Levi Kuhn, o=Index NDT Inspections Ltd., ou=Index NDT Inspections Ltd., email=LEVI@IN DEXNDT.CA, c=CA	REPAIRS: NA
