**INSPECTION SERVICES AND ENGINEERING CERTIFICATION**
**AB: 780.870.1547 SK: 306.250.9294 Head Office Mail: P.O. Box 10524 Lloydminster, AB T9V 3A6**
**INSPECTION REPORT**

<b>CLIENT:</b>	K&S Power Tongs	<b>UNIT/RIG:</b>	KSV010
<b>EQUIPMENT:</b>	Volant Tool	<b>MAKE/MODEL:</b>	Volant CRTi2-4.5
<b>RATING:</b>	N/A	<b>SERIAL NUMBER:</b>	KSV010

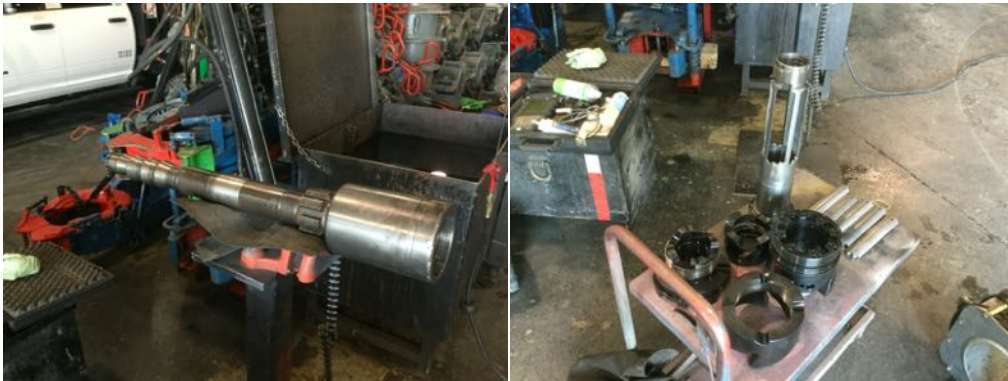
**EQUIPMENT PHOTOS**

<b>Part:</b> Mandrel 82304-03-4437A01-06 Cage 81325-4435A17-09 Upper Cam 81208-3J7423-01 Lower Cam 81221-4437A05-13 Cam Latch 81212-4437A06-10 Cam Int 80942-4437A03-13 Die - 80957-01-4589A11-44 Die - 80957-01-4589A11-48 Die - 80957-01-4589A11-45 Die - 80957-01-4589A11-46 Die - 80957-01-4589A11-06	
			<b>Serial#:</b> 82304-03-4437A01-06 81325-4435A17-09 81208-3J7423-01 81221-4437A05-13 81212-4437A06-10 80942-4437A03-13 80957-01-4589A11-44 80957-01-4589A11-48 80957-01-4589A11-45 80957-01-4589A11-46 80957-01-4589A11-06	
			<b>Material Thickness:</b> 0.904/0.898/0.903/0.903/0.896	
			<b>REPAIRS:</b> Upper Cam 81208-4437A04-15 has several cracks and was replaced with a new one.
