CERTIFICATE OF COMPLIANCE

CLIENT:	K & S Power Tongs
UNIT:	KS 303
EQUIPMENT:	Tubing Elevator
MANUFACTURER:	BVM
MODEL:	3 1/2"
RATING:	100 Ton
SERIAL #:	4198
LOCATION:	Lloydminster, AB
INSPECTION DATE:	May 29, 2023

INSPECTION REPORT

CLIENT:	K&S Power Tongs	UNIT/REPORT#:	KS 303/IDX-3615
EQUIPMENT:	Tubing Elevator	MAKE/MODEL:	BVM/3 1/2"
RATING:	100 Ton	SERIAL NUMBER:	4198

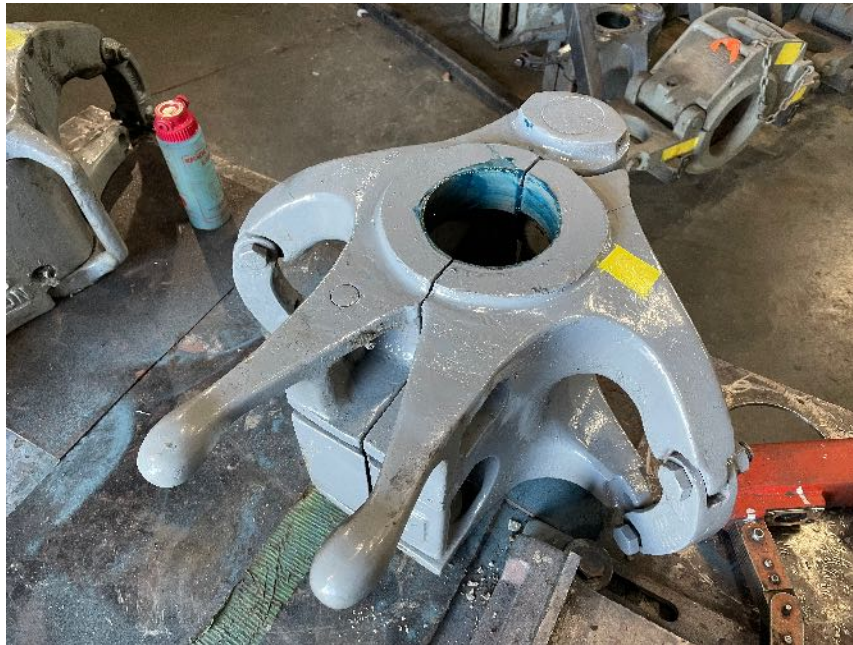
EQUIPMENT PHOTOS

ACCEPTABLE:	<input checked="" type="checkbox"/>	REJECTED:	<input type="checkbox"/>	DATE OF INSPECTION:	May 29, 2023
TECHNICIAN:		COMMENTS: NA
