INSPECTION REPORT

CLIENT:	K&S Power Tongs	UNIT/RIG:	KSV005
EQUIPMENT:	Volant Tool	MAKE/MODEL:	Volant CRTi2-4.5
RATING:	N/A	SERIAL NUMBER:	KSV005

INSPECTION CERTIFICATE

Field Report

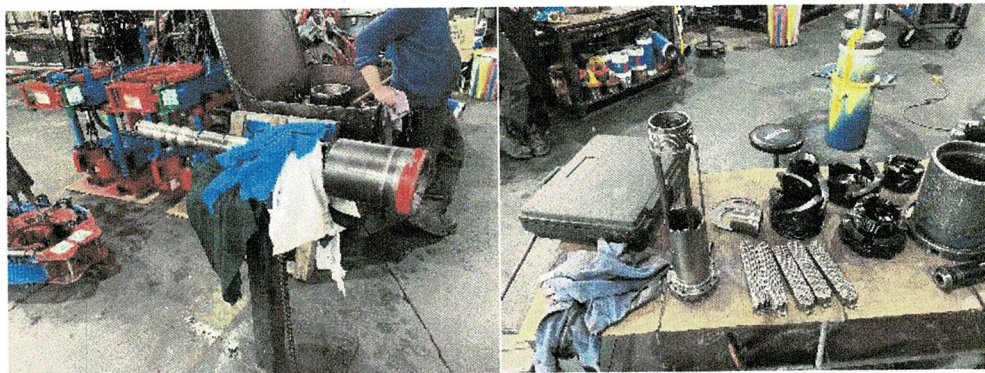
EQUIPMENT PHOTOS

ACCEPTABLE:	X	REJECTED:	DATE OF INSPECTION:	April 27, 2023
TECHNICIAN:			COMMENTS:

Part:	Serial#:
			Mandrel	82304-03-4402A01-01
			Cage	81325-4435A17-02
			Upper Cam	81208-4437A04-07
			Lower Cam	81221-4437A05-04
			Cam Latch	81212-4437A06-02
			Cam Int.	80942-4437A03-05
			Die -	80980-01-4488A01-27
			Die -	80980-01-4488A01-28
			Die -	80980-01-4488A01-30
			Die -	80980-01-4400A02-63
			Die -	80980-01-4400A02-64
			Mandrel Thickness: 0.883/ 0.886/ 0.881/ 0.880/ 0.881	
			REPAIRS: NA

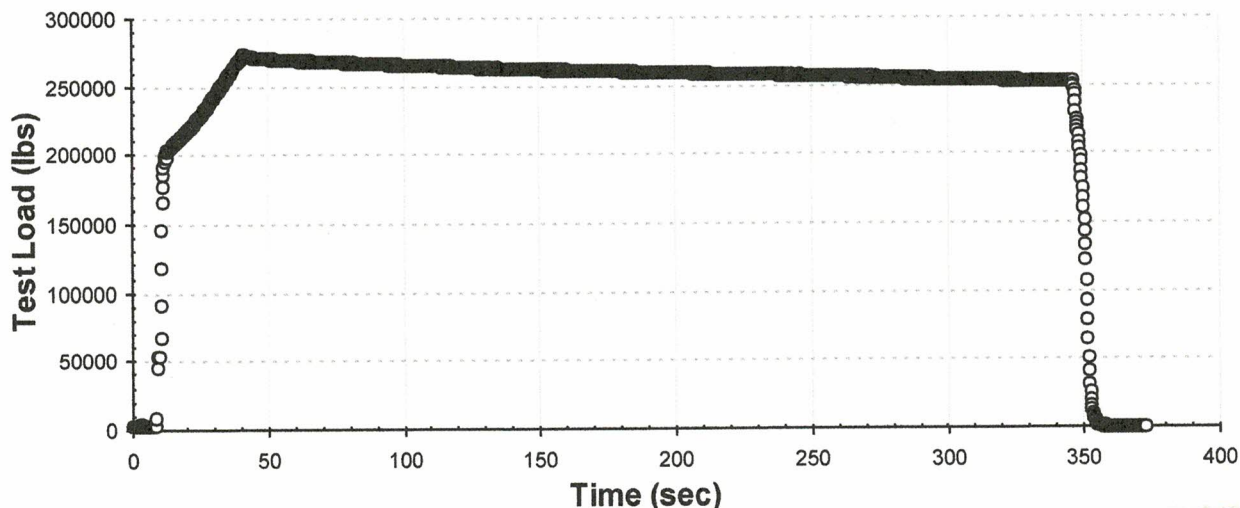
Proof Load Test 264000 lbs
Test Method: Proof 1.10

Test Date 31-Mar-22
Peak Load 272696 lbs

Required Duration (sec) 300

Passed ☒
