### INSPECTION REPORT

CLIENT:	K&S Power Tongs	UNIT/REPORT#:	KSV007/IDX-3106
EQUIPMENT:	Volant Tool	MAKE/MODEL:	Volant CRTI3-7.0
RATING:	N/A	SERIAL NUMBER:	KSV007

## INSPECTION CERTIFICATE

## Field Report

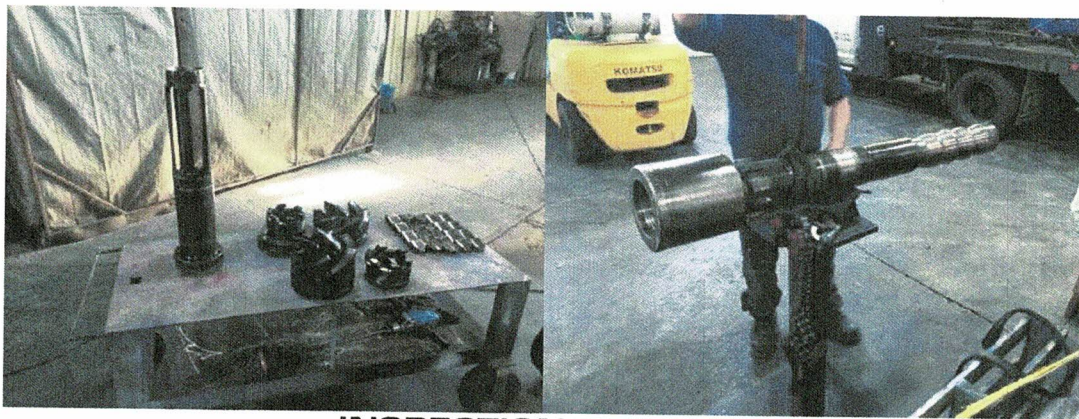
### EQUIPMENT PHOTOS

ACCEPTABLE:	X	REJECTED:		DATE OF INSPECTION:	March 23, 2023
TECHNICIAN:		COMMENTS:			
		Part:	Serial#:		
		Mandrel	82306-03-4527A01-01		
		Cage	82856-4501A02-12		
		Upper Cam	81190-4517A04-04		
		Lower Cam	81191-4527A05-04		
		Cam Latch	80813-4517A07-02		
		Cam Int.	80810-4527A03-02		
		Die - 7" (17-26)	80928-01-3J1145-05		
		Die - 7" (17-26)	80928-01-4411A15-30		
		Die - 7" (17-26)	80928-01-4411A15-29		
		Die - 7" (17-26)	80928-01-4419A01-03		
		Die - 7" (17-26)	80928-03-3J7201-06		
		Mandrel UT Measurements:	1.306, 1.305, 1.310, 1.305, 1.310		
		REPAIRS:	NA
