INSPECTION REPORT

CLIENT:	K&S Power Tongs	UNIT/REPORT#:	KSV007/IDX-5324
EQUIPMENT:	Volant Tool	MAKE/MODEL:	Volant CRTi3-7.0
RATING:	N/A	SERIAL NUMBER:	KSV007

INSPECTION CERTIFICATE

CERTIFICATION OF: CRT Mandrel
MAKE: Volant
MODEL: CRTi3-7.0
SERIAL NUMBER: 82306-03-4527A01-01
UNIT NUMBER: NA
CAPACITY: 320 ton
OWNER: K & S Power Tongs

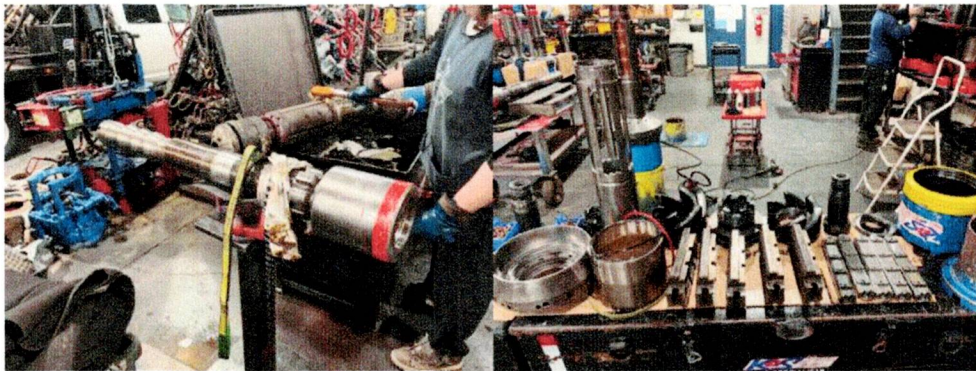
EQUIPMENT PHOTOS

Part:	Serial#:	
			Mandrel	82306-03-4527A01-01	
			Cage	82856-4501A02-12	
			Upper Cam	81190-4517A04-04	
			Lower Cam	81191-4527A05-04	
			Cam Latch	80813-4517A07-02	
			Cam Int.	80810-4527A03-02	
			Die - 7" [17-26]	80929-01-3J4155-71	
			Die - 7" [17-26]	80929-01-4624A16-37	
			Die - 7" [17-26]	80929-01-4466A01-30	
Die - 7" [17-26]	80929-01-4538A03-71				
Die - 7" [17-26]	80929-01-3J4155-69				
Jaw	81955-02-4521A16-18				
Jaw	81955-02-4521A16-12				
Jaw	81955-02-4521A16-16				
Jaw	81955-02-4521A16-14				
Jaw	81955-02-4521A16-15				
Mandrel UT Measurements:			1.272, 1.270, 1.271, 1.273, 1.269		
REPAIRS: NA

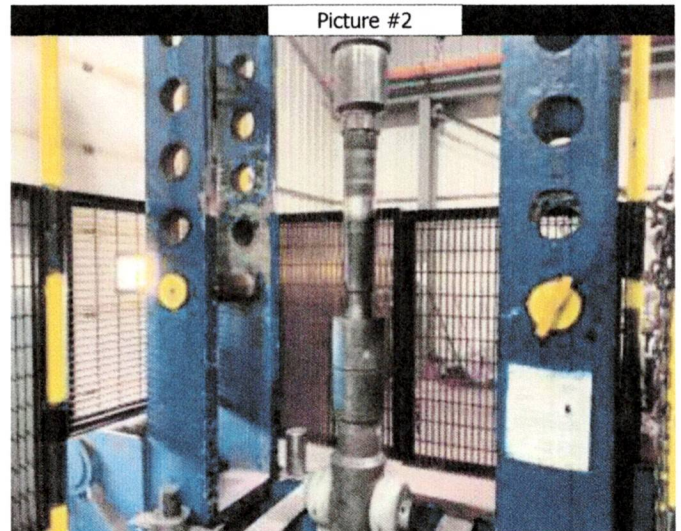
Pre Load Test - CRT Mandrel: No relevant indications or damage was noted at the time of inspection. 4 1/2" IF Box Plug Gauge Passed.
 Post Load Test - CRT Mandrel: No relevant indications or damage was noted at the time of inspection.

5-Wall Thickness Readings Taken: 1.258", 1.254", 1.255", 1.259", 1.256" Average Thickness: 1.256"
 Areas scanned around and lowest readings recorded.
 O.D. was measured at the same spot as wall thickness readings: O.D. 3.989"
