INSPECTION REPORT

CLIENT:	K&S Power Tongs	UNIT/RIG:	KSV009
EQUIPMENT:	Volant Tool	MAKE/MODEL:	Volant CRTi3-7.0
REPORT#:	IDX-5354	SERIAL NUMBER:	KSV009

INSPECTION CERTIFICATE

LOAD TEST CERTIFICATE

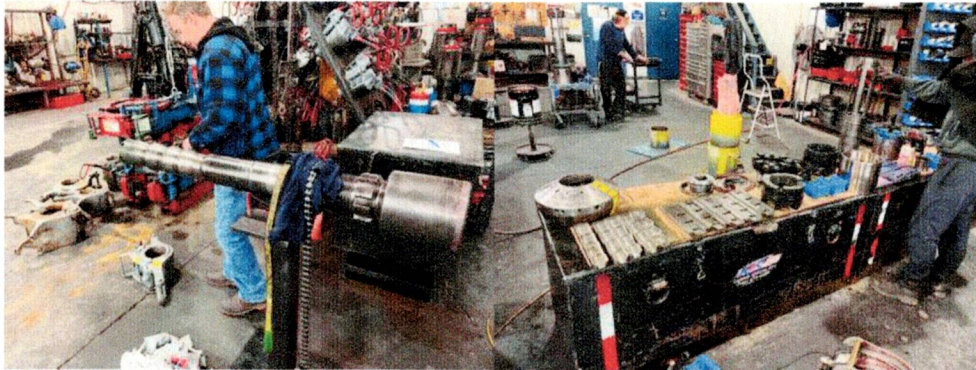
EQUIPMENT PHOTOS

ACCEPTABLE:	X	REJECTED:		DATE OF INSPECTION:	April 18, 2024
TECHNICIAN:			COMMENTS:

Part: Mandrel- 82306-03-4501A01-12 Cage- 82856-4501A02-08 Upper Cam - 81190-4501A04-14 Lower Cam - 81191-4501A05-13 Cam Latch - 80813-4501A06-12 Cam Int - 80810-4501A03-13 Die- 80987-02-4022807-09 Die- 80987-02-4022807-07 Die- 80987-02-4589A06-02 Die- 80987-02-4022807-06 Die- NA Jaw- 80929-01-4466A01-27 Jaw- 80929-01-4466A01-21 Jaw- 80929-01-3J1147-31 Jaw- 80929-01-4538A03-75 Jaw- 80929-01-4538A03-73 MANDREL THICKNESS: 1.266/ 1.268/ 1.264/ 1.271/ 1.263		
			REPAIRS: NA
