INSPECTION REPORT

CLIENT:	K&S Power Tongs	UNIT/RIG:	KSV006
EQUIPMENT:	Volant Tool	MAKE/MODEL:	Volant CRTi2-4.5
REPORT#:	IDX-5386	SERIAL NUMBER:	KSV006

INSPECTION CERTIFICATE

CERTIFICATION OF: CRT Mandrel
MAKE: Volant
MODEL: CRTi2-4.5
SERIAL NUMBER: 82304-03-4437A01-01
UNIT NUMBER: NA
CAPACITY: 120 ton
OWNER: K & S Power Tongs

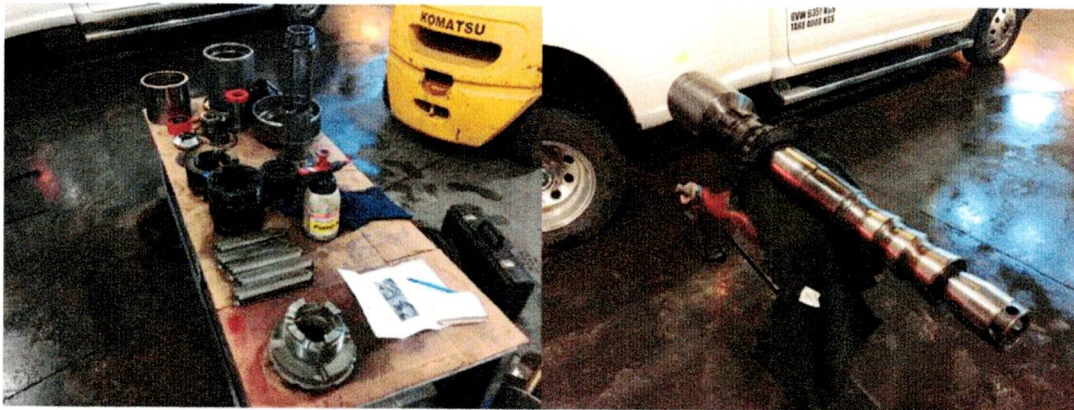
EQUIPMENT PHOTOS

ACCEPTABLE:	X	REJECTED:		DATE OF INSPECTION:	April 24, 2024
TECHNICIAN:			COMMENTS:

Part: Mandrel Cage Upper Cam Lower Cam Cam Latch Cam Int Die - Die - Die - Die - Die -		
			Serial#: 82304-03-4437A01-01 80939-4268A11-03 81208-3J6957-02 81221-4437A05-09 81212-4437A06-06 80942-4437A03-09 80980-01-4488A01-44 80980-01-4488A01-45 80980-01-4488A01-48 80980-01-4488A01-47 80980-01-4488A01-48		
			Material Thickness: 0.862"/ 0.860"/ 0.859"/ 0.861"/ 0.857"		
			REPAIRS: NA

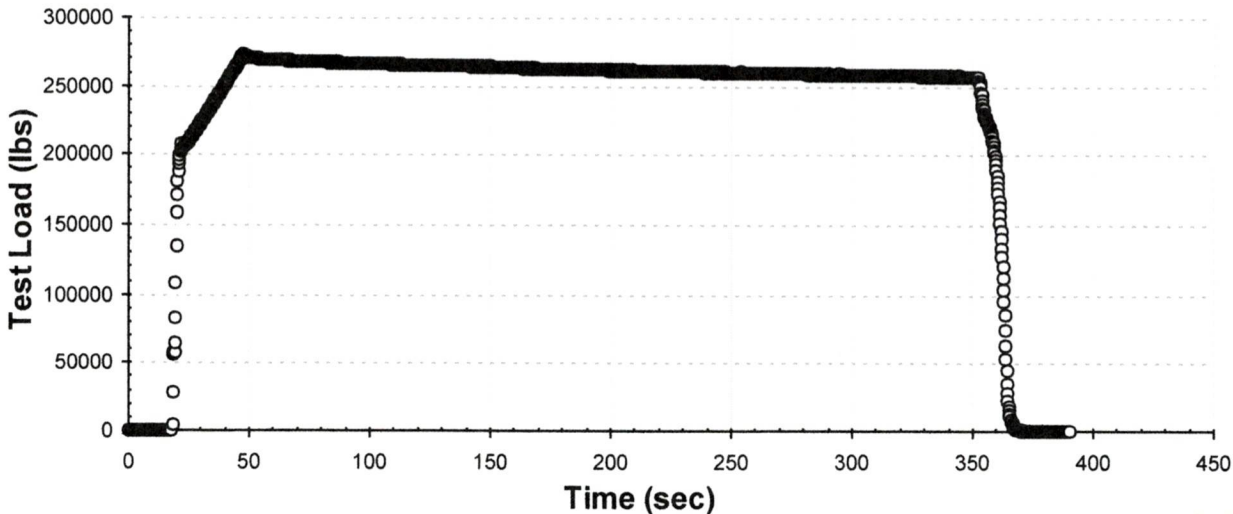
Proof Load Test 264000 lbs **Test Date** 31-Mar-22 **Required Duration (sec)** 300
Test Method: Proof 1.10 **Peak Load** 272696 lbs **Passed**
