### INSPECTION REPORT

<b>CLIENT:</b>	K&S Power Tongs	<b>UNIT/RIG:</b>	KSV006
<b>EQUIPMENT:</b>	Volant Tool	<b>MAKE/MODEL:</b>	Volant CRTi2-4.5
<b>REPORT#:</b>	IDX-9323	<b>SERIAL NUMBER:</b>	KSV006

## INSPECTION CERTIFICATE

**CERTIFICATION OF:** CRT Mandrel  
**MAKE:** Volant  
**MODEL:** CRTi2-4.5  
**SERIAL NUMBER:** 82304-03-4437A01-01  
**UNIT NUMBER:** NA  
**CAPACITY:** 120 ton  
**OWNER:** K & S Power Tongs

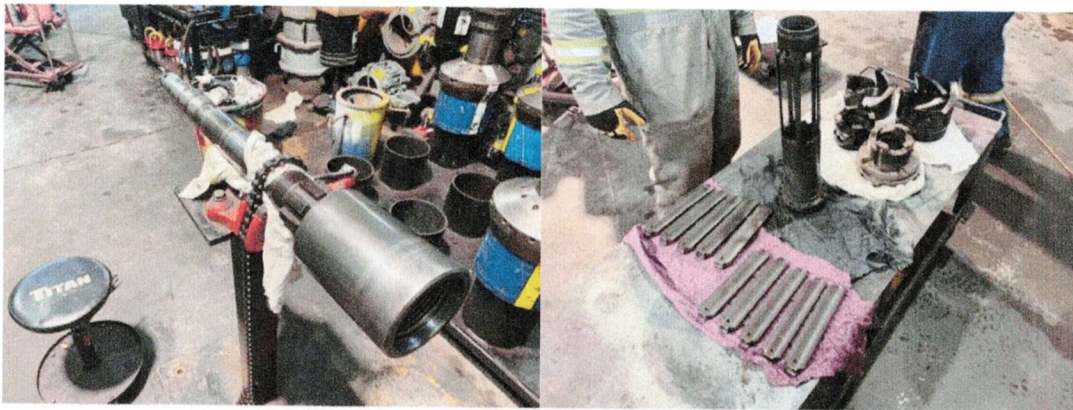
### EQUIPMENT PHOTOS

<b>ACCEPTABLE:</b>	X	<b>REJECTED:</b>		<b>DATE OF INSPECTION:</b>	March 23, 2026
<b>TECHNICIAN:</b>			<b>COMMENTS:</b>

<b>Part:</b> Mandrel 82304-03-4437A01-01 Cage 80939-4268A11-03 Upper Cam 81208-3J6957-02 Lower Cam 81221-4437A05-09 Cam Latch 81212-4437A06-06 Cam Int 80942-4437A03-09 Die - 80957-01-3J3508-09 Die - 80957-01-4589A11-12 Die - 80957-01-4400A01-68 Die - 80957-01-4448A01-31 Die - 80957-01-4448A01-33 Die - 80957-01-4589A11-24 Die - 80957-01-4589A11-10 Die - 80957-01-4589A11-46 Die - 80957-01-4589A11-45 Die - 80957-01-4589A11-47		
			<b>Serial#:</b> 82304-03-4437A01-01 80939-4268A11-03 81208-3J6957-02 81221-4437A05-09 81212-4437A06-06 80942-4437A03-09 80957-01-3J3508-09 80957-01-4589A11-12 80957-01-4400A01-68 80957-01-4448A01-31 80957-01-4448A01-33 80957-01-4589A11-24 80957-01-4589A11-10 80957-01-4589A11-46 80957-01-4589A11-45 80957-01-4589A11-47		
			<b>Material Thickness:</b> 0.890"/ 0.880"/ 0.889"/ 0.886"/ 0.888"

<b>REPAIRS:</b> NA
