INSPECTION REPORT

CLIENT:	K&S Power Tongs	UNIT/REPORT#:	KSV008/IDX-9589
EQUIPMENT:	Volant Tool	MAKE/MODEL:	Volant CRTi2-4.5
RATING:	N/A	SERIAL NUMBER:	KSV008

INSPECTION CERTIFICATE

LOAD TEST CERTIFICATE

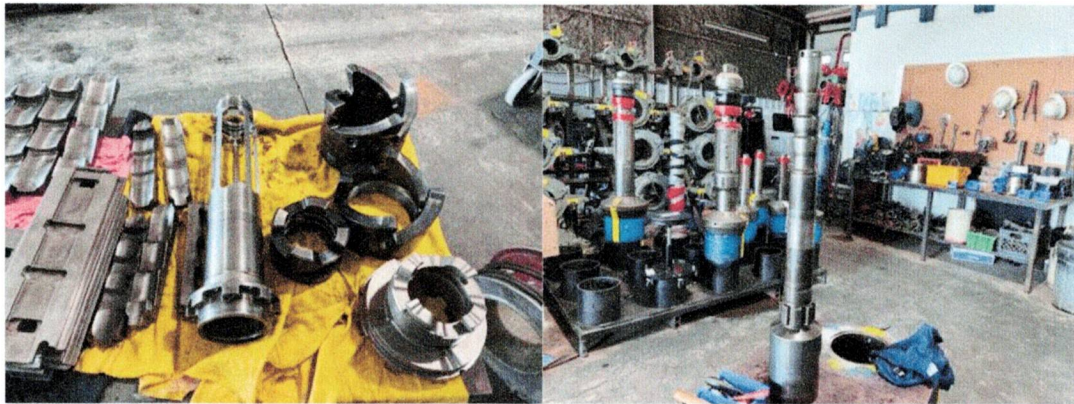
EQUIPMENT PHOTOS

ACCEPTABLE:	X	REJECTED:		DATE OF INSPECTION:	April 21, 2026
TECHNICIAN:			COMMENTS:

Part: Mandrel Cage Upper Cam Lower Cam Cam Latch Cam Int Die - Die - Die - Die - Die - Die -		
			Serial#: 82304-03-4437A01-04 81325-4435A17-10 81208-3J9258-01 81221-4437A05-11 81212-4437A06-08 80942-4437A03-11 80980-01-4488001-13 80980-01-3111581-16 80980-01-4488A01-15 80980-01-3111581-22 80980-01-4488A01-11		
			Material Thickness: 0.881/ 0.879/ 0.876/ 0.879/ 0.871		
			REPAIRS:
