## INSPECTION SERVICES AND ENGINEERING CERTIFICATION

### INSPECTION REPORT

<b>CLIENT:</b>	K&S Power Tongs	<b>UNIT/RIG:</b>	KSV014
<b>EQUIPMENT:</b>	Volant Tool	<b>MAKE/MODEL:</b>	Volant CRTI3-7.0
<b>REPORT#:</b>	IDX-9460	<b>SERIAL NUMBER:</b>	KSV014

## MAGNETIC PARTICLE TESTING REPORT - 323712

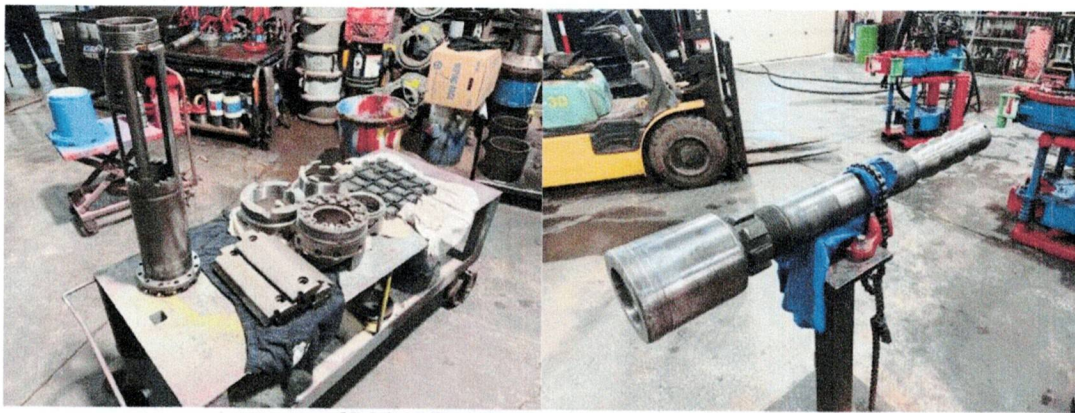
### EQUIPMENT PHOTOS

<b>ACCEPTABLE:</b>	X	<b>REJECTED:</b>		<b>DATE OF INSPECTION:</b>	April 7, 2026
<b>TECHNICIAN:</b>			<b>COMMENTS:</b>

<b>Part:</b>	<b>Serial#:</b>	
			Mandrel-	82306-12-3J11582-01	
			Cage-	82856-3J11712-02	
			Upper Cam -	102348-3J11793-07	
			Lower Cam -	102351-3J11792-01	
			Cam Latch -	102349-3J10780-13	
			Cam Int -	104338-3J11100-06	
			Die-	80929-03-3J11500-01	
			Die-	80929-03-3J11500-03	
			Die-	80929-03-3J11500-04	
Die-	80929-03-3J11500-06				
Die-	80929-03-3J11500-05				
Jaw-	82749-02-3J3980-18				
Jaw-	82749-02-3J3980-14				
Jaw-	82749-02-3J3980-16				
Jaw-	82749-02-3J3980-15				
Jaw-	82749-02-4473A12-11				
			<b>MANDREL THICKNESS:</b> 1.330/1.331/1.329/1.330/1.327		
			<b>REPAIRS:</b> NA

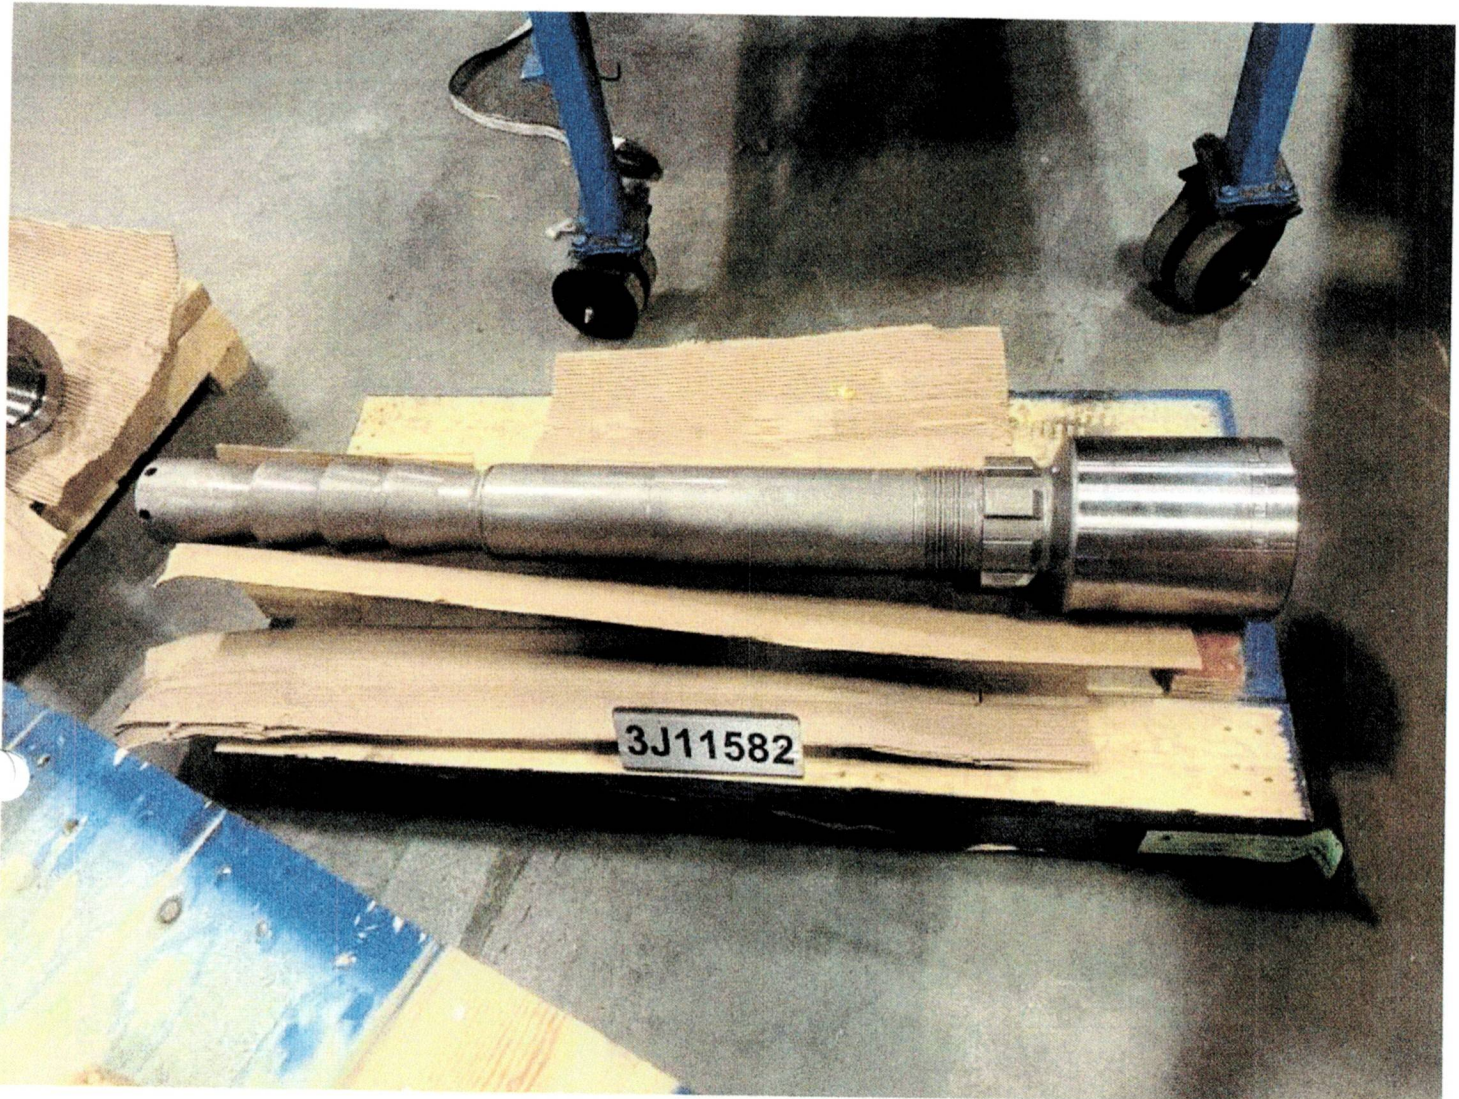
IMG\_7185

NO RELEVANT INDICATIONS WERE DETECTED AT TIME OF TESTING.  
BLACK LIGHT INTENSITY AT INSPECTION SURFACE WAS GREATER THAN 1000 MICRO WATTS.  
YOKE VERIFIED DAILY BEFORE USE WITH ALTERNATING CURRENT SUSTAINED LIFT USING (10 Ibs.2oz) CAL BLOCK
