INSPECTION SERVICES AND ENGINEERING CERTIFICATION
AB: 780.870.1547 SK: 306.250.9294 Head Office Mail: P.O. Box 10524 Lloydminster, AB T9V 3A6
INSPECTION REPORT

CLIENT:	K&S Power Tongs	UNIT/RIG:	KSV005
EQUIPMENT:	Volant Tool	MAKE/MODEL:	Volant CRTi2-4.5
RATING:	N/A	SERIAL NUMBER:	KSV005

Description: Casing Running Tool (Internal)

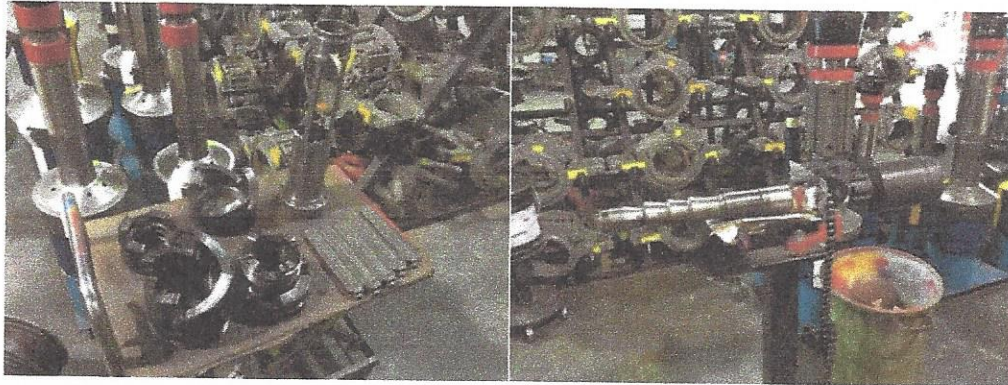
EQUIPMENT PHOTOS

ACCEPTABLE:	X	REJECTED:		DATE OF INSPECTION:	March 27, 2019
TECHNICIAN:			COMMENTS:

<p>cn=Levi Kuhn, o=Index NDT Inspections Ltd., ou=Index NDT Inspections Ltd., email=LEVI@IN DEXNDT.CA, c=CA</p>			Part: Mandrel Cage Upper Cam Lower Cam Cam Latch Cam Int. Die - 4.5(9.5-11.6lbs.) Die - 4.5(9.5-11.6lbs.) Die - 4.5(9.5-11.6lbs.) Die - 4.5(9.5-11.6lbs.) Die - 4.5(9.5-11.6lbs.) Die - 4.5(9.5-11.6lbs.)		
			Serial#: 82304-03-4402A01-01 81325-4435A17-02 81208-4437A04-07 81221-4437A05-04 81212-4437A06-02 80942-4437A03-05 80957-01-4589A11-27 80957-01-4589A11-08 80957-01-4589A11-09 80957-01-4448A01-29 80957-01-4448A01-30		
			Material Thickness: 0.860/0.861/0.862/0.865/0.864		
			REPAIRS: NA
