**INSPECTION REPORT**

<b>CLIENT:</b>	K&S Power Tongs		<b>UNIT/RIG:</b>	KSV003	
<b>EQUIPMENT:</b>	Volant Tool		<b>MAKE/MODEL:</b>	Volant CRTi2-4.5	
<b>RATING:</b>	N/A		<b>SERIAL NUMBER:</b>	KSV003

ID Number: *KSV003*

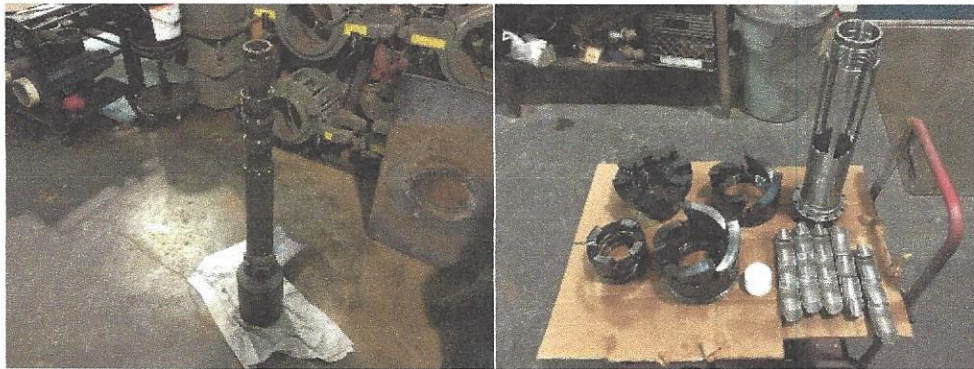
**EQUIPMENT PHOTOS**

<b>ACCEPTABLE:</b>	X	<b>REJECTED:</b>	<b>DATE OF INSPECTION:</b>	March 23, 2020	
<b>TECHNICIAN:</b>			<b>COMMENTS:</b>

<b>Part:</b>	<b>Serial#:</b>	
			Mandrel	82304-03-4402A01-03	
			Cage	81325-4435A17-06	
			Upper Cam	81208-4498A04-11	
			Lower Cam	81221-4437A05-05	
			Cam Latch	81212-4498A06-01	
			Cam Int	80942-4498A03-16	
			Die - 5.5(14-17lbs.)	80980-01-4400A02-64	
			Die - 5.5(14-17lbs.)	80980-01-4488A01-33	
			Die - 5.5(14-17lbs.)	80980-01-4488A01-31	
			Die - 5.5(14-17lbs.)	80980-01-4400A02-61	
			Die - 5.5(14-17lbs.)	80980-01-4488A01-29	
			<b>Material Thickness: 0.894/0.893/0.891/0.891/0.890</b>		
			<b>REPAIRS:</b>
