**INSPECTION SERVICES AND ENGINEERING CERTIFICATION**

**INSPECTION REPORT**

<b>CLIENT:</b>	K&S Power Tongs	<b>UNIT/RIG:</b>	KSV005
<b>EQUIPMENT:</b>	Volant Tool	<b>MAKE/MODEL:</b>	Volant CRTi2-4.5
<b>RATING:</b>	N/A	<b>SERIAL NUMBER:</b>	KSV005

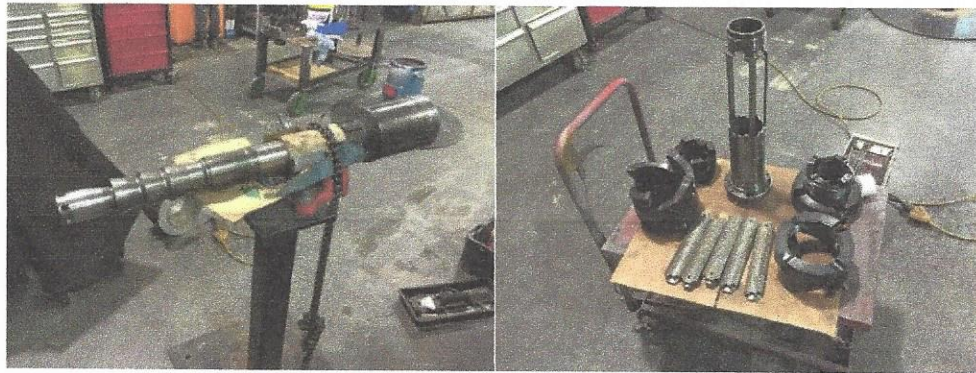
**EQUIPMENT PHOTOS**

<b>ACCEPTABLE:</b>	X	<b>REJECTED:</b>	<b>DATE OF INSPECTION:</b>	March 24, 2020
<b>TECHNICIAN:</b>			<b>COMMENTS:</b>

<b>Part:</b> Mandrel Cage Upper Cam Lower Cam Cam Latch Cam Int. Die - 4.5(9.5-11.6lbs.) Die - 4.5(9.5-11.6lbs.) Die - 4.5(9.5-11.6lbs.) Die - 4.5(9.5-11.6lbs.) Die - 4.5(9.5-11.6lbs.) Die - 4.5(9.5-11.6lbs.)	
			<b>Serial#:</b> 82304-03-4402A01-01 81325-4435A17-02 81208-4437A04-07 81221-4437A05-04 81212-4437A06-02 80942-4437A03-05 80957-01-4589A11-27 80957-01-4589A11-08 80957-01-4589A11-09 80957-01-4448A01-29 80957-01-4589A11-26	
			<b>Material Thickness:</b> 0.884/0.883/0.889/0.886/0.887	
			<b>REPAIRS:</b> NA
