INSPECTION REPORT

CLIENT:	K&S Power Tongs	UNIT/RIG:	KSV008
EQUIPMENT:	Volant Tool	MAKE/MODEL:	Volant CRTI2-4.5
RATING:	N/A	SERIAL NUMBER:	KSV008

Description: Casing Running Tool (Internal)
Tool Name Mandrel-05, CRTI2-4.5
Design Capacity: 240 kip
Test Temperature: 21.3 deg C
Manufacturer: Volant Oil Tools Inc.

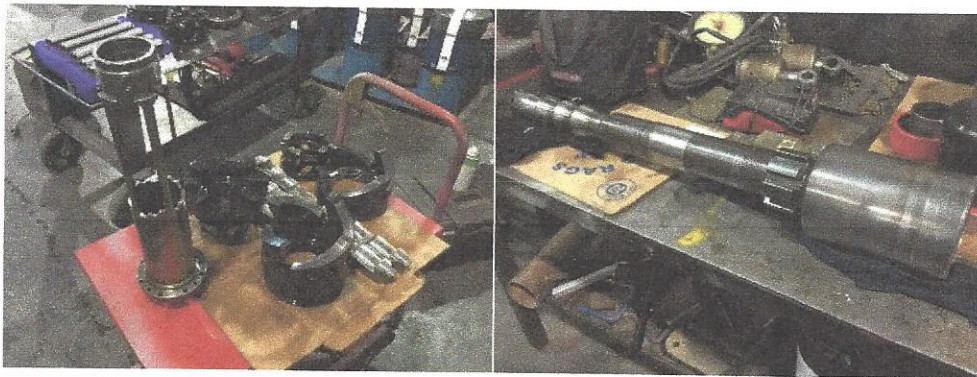
EQUIPMENT PHOTOS

ACCEPTABLE:	X	REJECTED:		DATE OF INSPECTION:	April 6, 2020
TECHNICIAN:			COMMENTS:

Part: Mandrel 82304-03-4437A01-04 Cage 81325-4435A17-10 Upper Cam 81208-4437A01-13 Lower Cam 81221-4437A05-11 Cam Latch 81212-4437A06-08 Cam Int 80942-4437A03-11 Die - 5.5(14-17 lbs.) 80980-01-4488A01-11 Die - 5.5(14-17 lbs.) 80980-01-4488A01-12 Die - 5.5(14-17 lbs.) 80980-01-4488A01-13 Die - 5.5(14-17 lbs.) 80980-01-4488A01-14 Die - 5.5(14-17 lbs.) 80980-01-4488A01-15		
			Serial#: 82304-03-4437A01-04 81325-4435A17-10 81208-4437A01-13 81221-4437A05-11 81212-4437A06-08 80942-4437A03-11 80980-01-4488A01-11 80980-01-4488A01-12 80980-01-4488A01-13 80980-01-4488A01-14 80980-01-4488A01-15		
			Material Thickness: 0.893/0.896/0.899/0.896/0.897		
			REPAIRS:
