**INSPECTION SERVICES AND ENGINEERING CERTIFICATION**
**AB: 780.870.1547 SK: 306.250.9294 Head Office Mail: P.O. Box 10524 Lloydminster, AB T9V 3A6**
**INSPECTION REPORT**

<b>CLIENT:</b>	K&S Power Tongs	<b>UNIT/RIG:</b>	KSV010
<b>EQUIPMENT:</b>	Volant Tool	<b>MAKE/MODEL:</b>	Volant CRTI2-4.5
<b>RATING:</b>	N/A	<b>SERIAL NUMBER:</b>	KSV010

Description: Casing Running Tool (Internal)

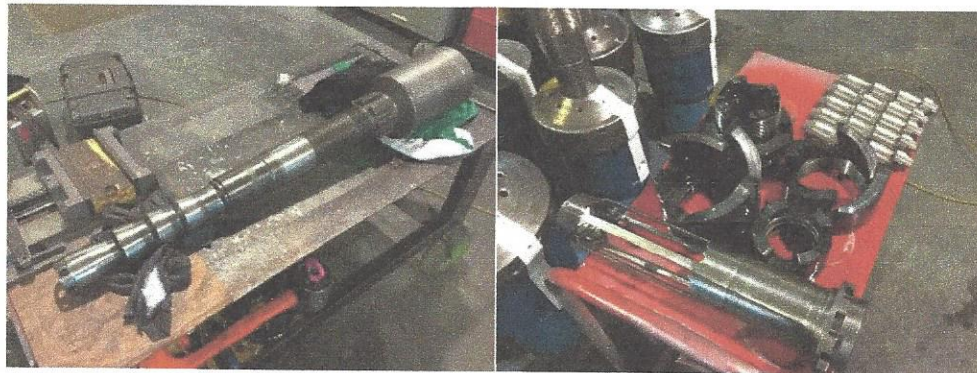
**EQUIPMENT PHOTOS**

<b>ACCEPTABLE:</b>	X	<b>REJECTED:</b>		<b>DATE OF INSPECTION:</b>	April 8, 2020
<b>TECHNICIAN:</b>			<b>COMMENTS:</b>		
 			<b>Part:</b> Mandrel 82304-03-4437A01-06 Cage 81325-4435A17-09 Upper Cam 81208-4437A04-15 Lower Cam 81221-4437A05-13 Cam Latch 81212-4437A06-10 Cam Int. 80942-4437A03-13 Die - 80957-01-4589A11-44 Die - 80957-01-4589A11-48 Die - 80957-01-4589A11-45 Die - 80957-01-4589A11-46 Die - 80957-01-4589A11-06		
			<b>Serial#:</b> 82304-03-4437A01-06 81325-4435A17-09 81208-4437A04-15 81221-4437A05-13 81212-4437A06-10 80942-4437A03-13 80957-01-4589A11-44 80957-01-4589A11-48 80957-01-4589A11-45 80957-01-4589A11-46 80957-01-4589A11-06		
			<b>Material Thickness:</b> 0.898/0.897/0.898/0.891/0.895		
			<b>REPAIRS:</b>
